Manhole Inspection Summary

Manhole # S45UU_029MH

Insp Date: **2/7/07 2:00 PM**

Location Address: **2728 FENWICK AVE**

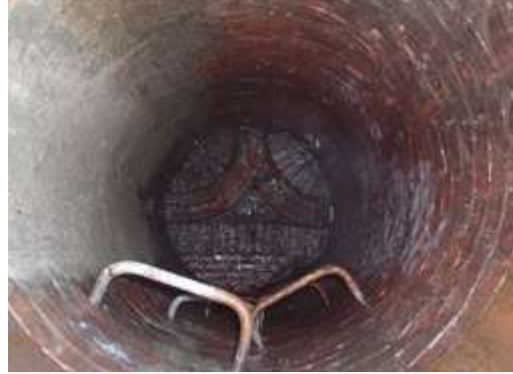
Top View

Corroded steps. Bench debris.

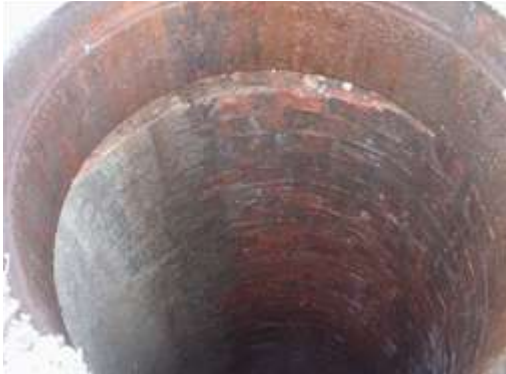
Defect

Frame leaks. Adjustment deterioration and infiltration. Barrel infiltration.

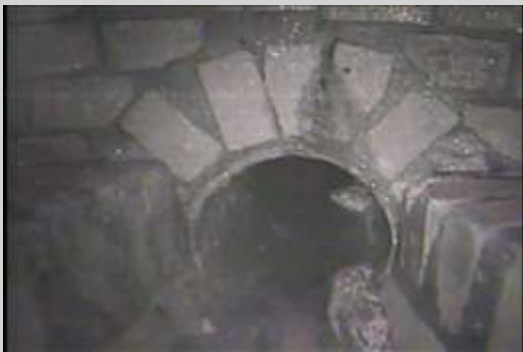
Pipe Out @ 12 O'Clock

Deposits: ☐ None ☐ Mud ☐ Sludge ☐ Debris ☒ Grease

Silt Depth: **0** (in.) Deposits Extent: **Light**

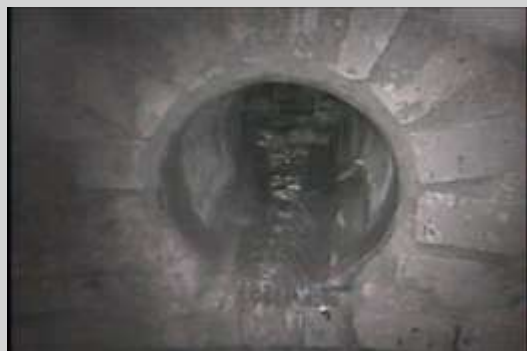
Pipe In @ 9 O'Clock

Deposits: ☐ None ☐ Mud ☐ Sludge ☒ **Debris** ☒ **Grease**

Silt Depth: **8** (in.)

Deposits Extent: **Heavy**

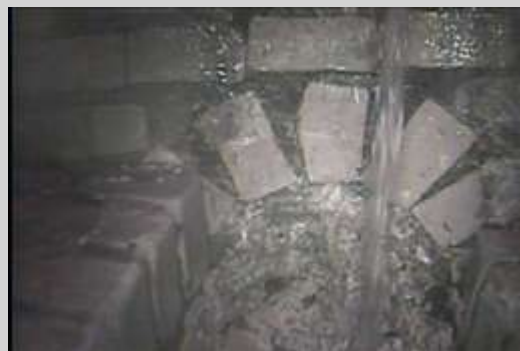
Drop In @ 9 O'Clock

Drop: **Outside** Rod and Bar

Drop Condition: **Clogged**
